# Protective Coatings at Work

## Concrete Footing Repair Procedure for Batch Kilns:

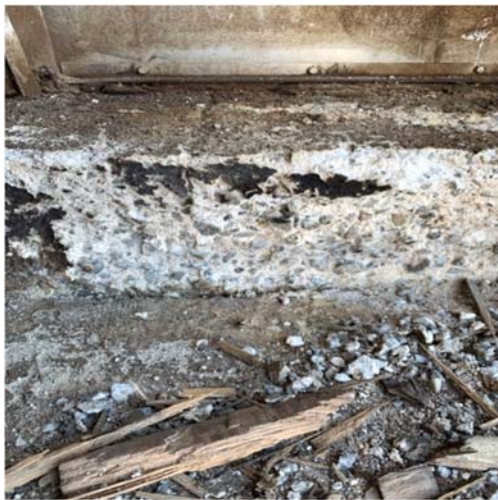
The above pictures show the concrete that was severely deteriorated from the combination of high temperature and tannic acid exposure for many years. The existing coating system that was applied did not protect the concrete and failed over time due to the acidic service environment. Approximately 1/4" – 1/2" (6mm - 12mm) of deteriorated concrete was removed with a needle gun power tool to a surface condition where the existing concrete was sound and free of laitance and any loose deteriorated concrete. Cracks within the concrete were opened-up with the power tool cleaning to enable them to be properly filled in with the new Protexior coating repair system.

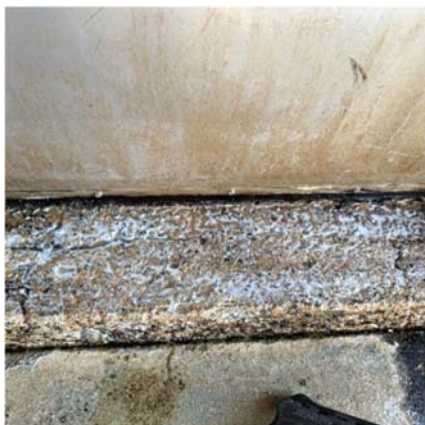
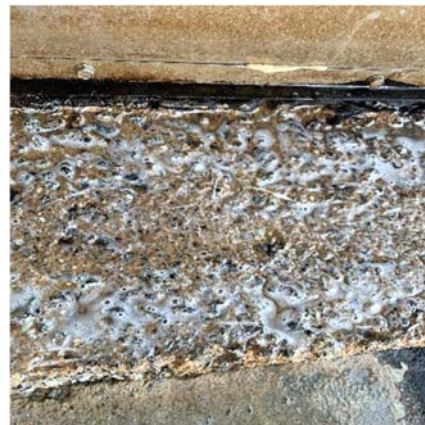
The above pictures show the concrete footing being washed with an alkaline cleaner and an all-purpose cleaner to remove any dirt residue. The alkaline cleaner was used to neutralize the acidic surface from being exposed to the tannic acid; to a neutral PH of 7. The gap at the floor to footer transition was previously caulked. The caulk was removed due to a loss of adhesion to the concrete.

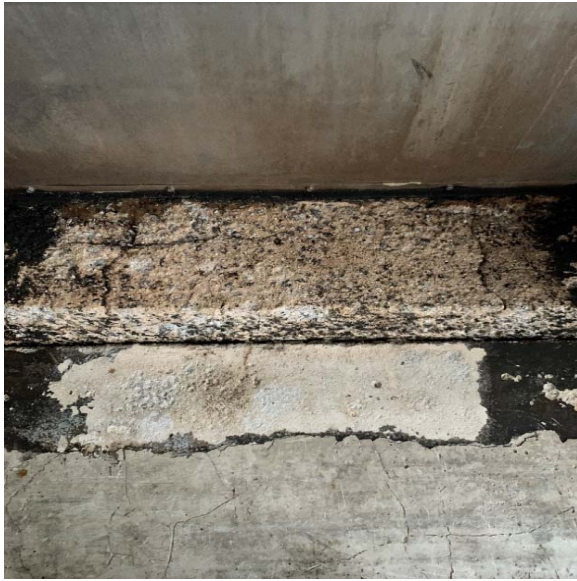
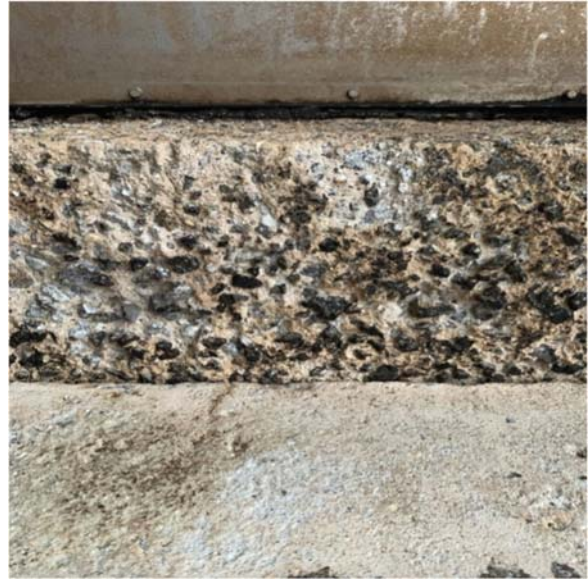
The above pictures show the concrete was prepared to an ASTM D4259 (Standard Practice for Abrading Concrete) with a surface roughness in accordance to ICRI CSP 6-8. The footing and approximately 10"-12" (254mm – 305mm) out onto the floor were prepared for the coating repair.

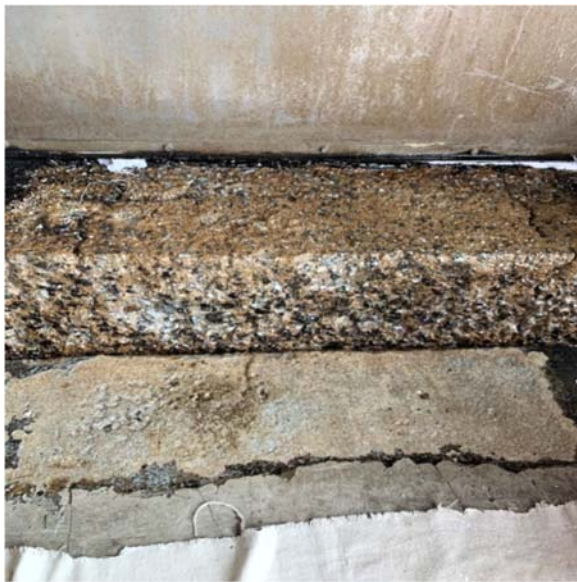
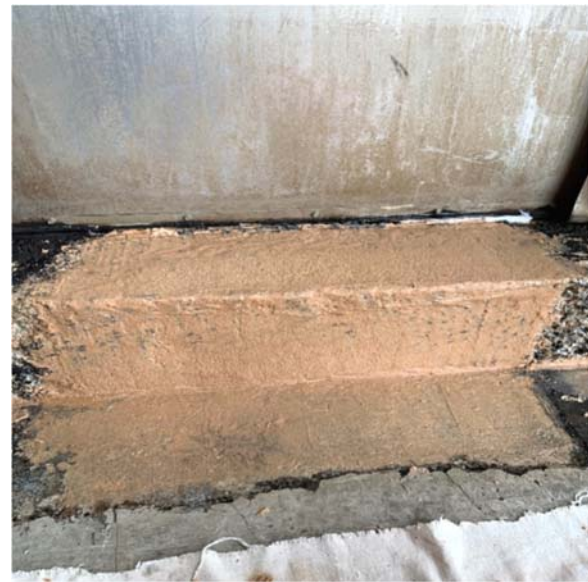
The above pictures show the coating repair with the Dampney Protexior 793 Epoxy Coating. The picture on the left shows the concrete after being primed with just the mixed liquid A and B components. The picture on the right shows the Dampney Protexior 793 Epoxy Coating after being thickened into a mortar and applied to the concrete to build up the deteriorated areas of the concrete. The mortar was applied between 1/8"- 1 1/2" (3mm – 38mm) to rebuild the deteriorated concrete surface and to establish a smoother surface for the finish coat to be applied. The gap at the floor to footer transition that was previously caulked was filled in with the Dampney Protexior 793 mortar, after first being wet primed with just the liquid Protexior 793.

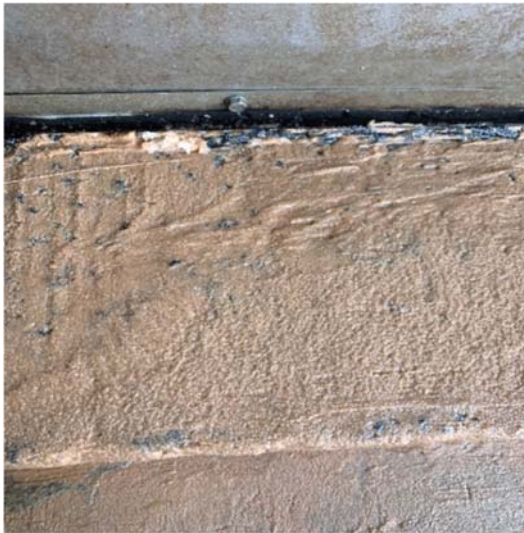
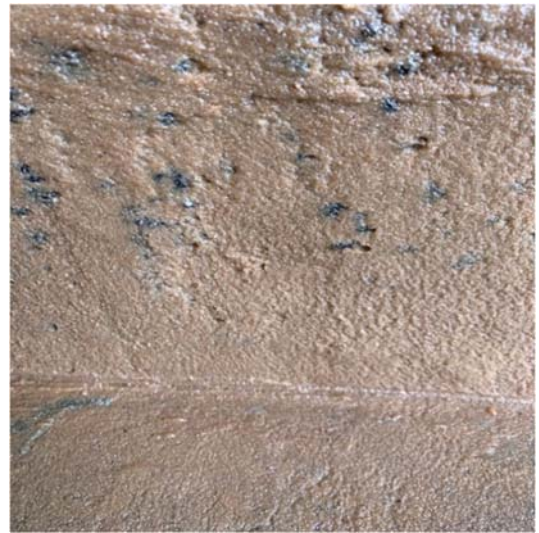
The above pictures show the applied Dampney Protexior 793 mortar. The picture on the left shows the top of the footer that is horizontal and the picture on the right shows the vertical surfaced of the footer. The picture on the right also shows the floor to footer gap; that was filled in with the Dampney Protexior 793 epoxy mortar.

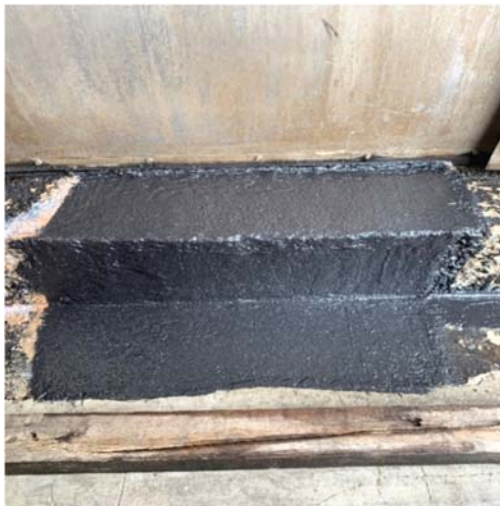
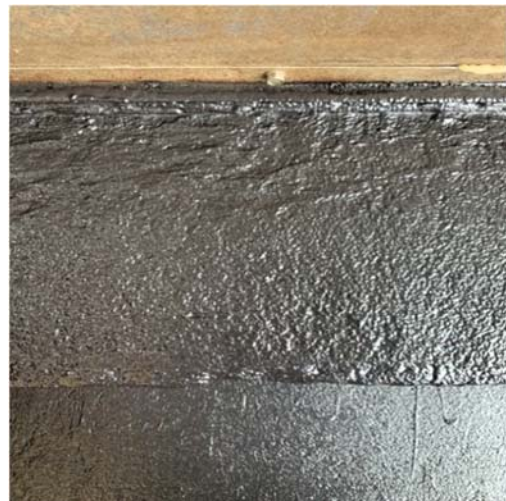
The above pictures show the finish coat of Dampney Protexior 794 applied to the concrete footing and floor area of the kiln at a dry film thickness of 4.0 - 6.0 mils (100 - 150 microns). This finish coat was chosen due to its ability to resist a wide range of acids, oils and chemical exposures and its excellent resistance to wet/dry thermal cycling when the kiln is in operation.
